Turin, 30<sup>th</sup> September 2011

## **CAMPAIGN 5593 - Recall Campaign**

**Model: Fiat Ducato all models**

**- U-bolts fixing the leaf spring to the rear axle**

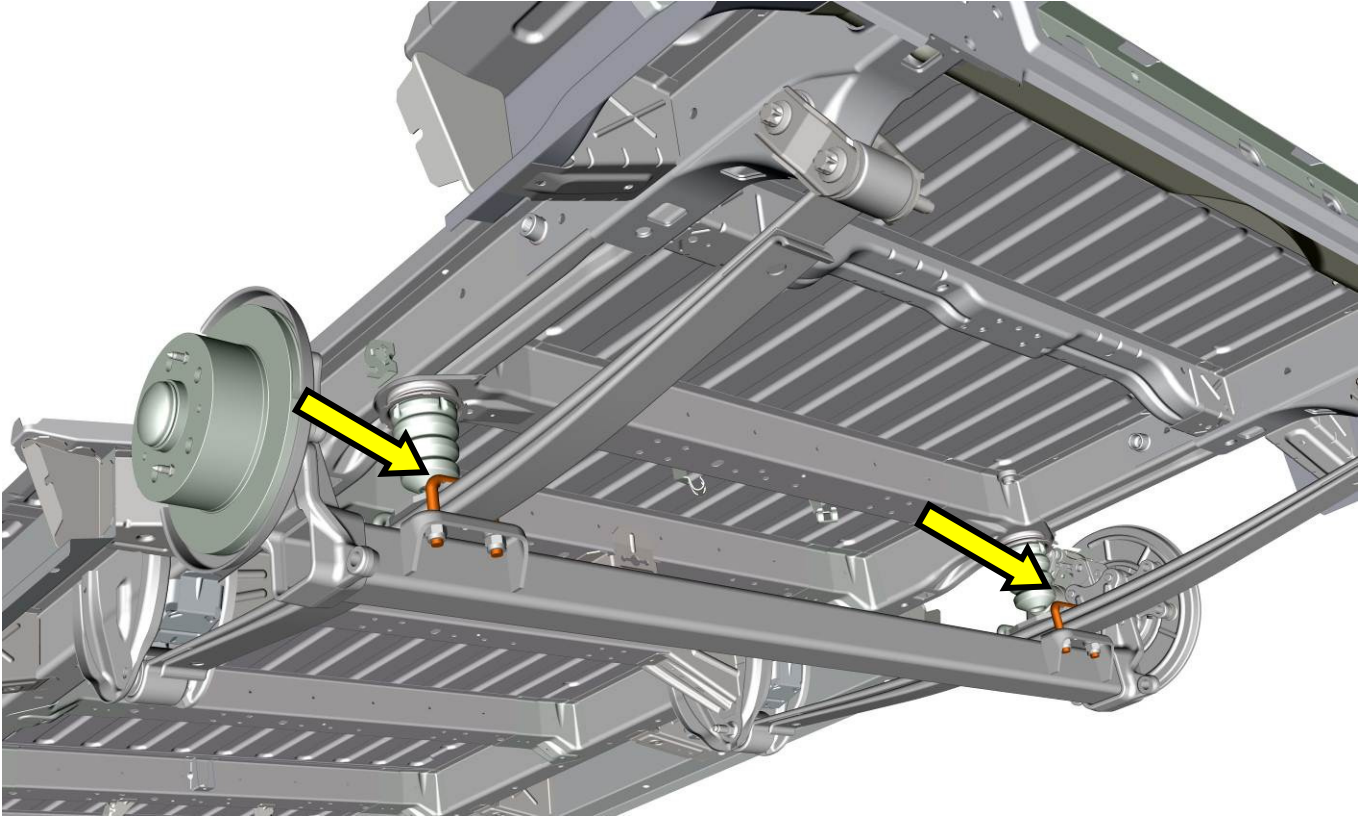
- Position the vehicle on the lift.
- Identify the left and right U-bolts fixing the leaf spring to the rear axle.

- Remove the left and right U-bolts fixing the leaf spring to the rear axle.
- Replace the right and left U-bolts of the rear suspension checking the version (Light or Heavy) where the operation is to be carried out (see Part&Service availability).
- Replace the nut, the flat washer and the tapered washer (see Part&Service availability), as shown.
