**CAMPAIGN 5623 - Service Campaign**

**Model: Fiat Ducato with 2.3 JTD 130 HP and 150 HP Euro 5 engine  
- engine compartment junction unit**

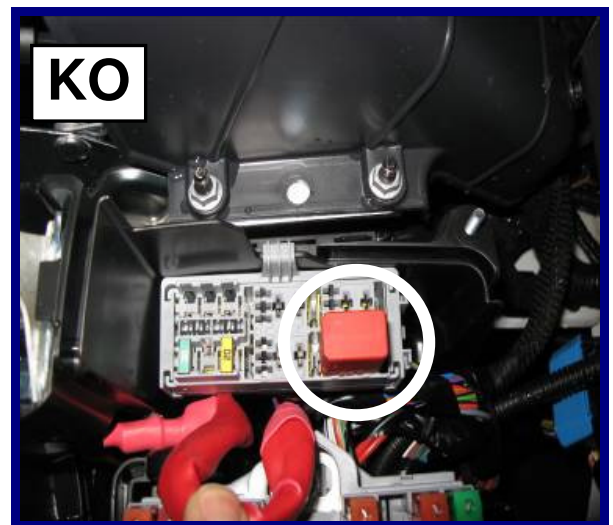
- Remove the relay switch on the junction unit, from position T27 (wrong).
