**CAMPAIGN 5559 - Service Campaign**

**Model: Fiat Ducato with 2.3 JTD 130 HP E5 engine**

- engine ECU
- engine compartment layout

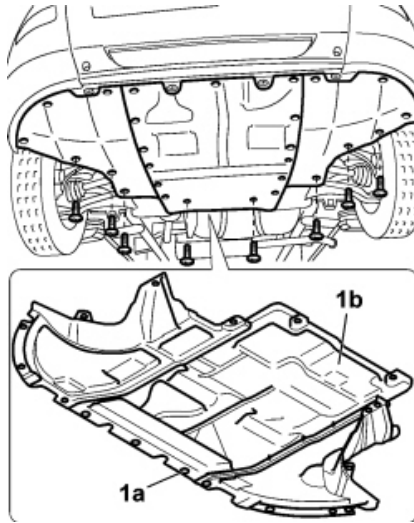
- Position the vehicle on the lift
- Undo the fixing screws (1a) and remove the complete under-engine guard (1b) from the vehicle, if present.

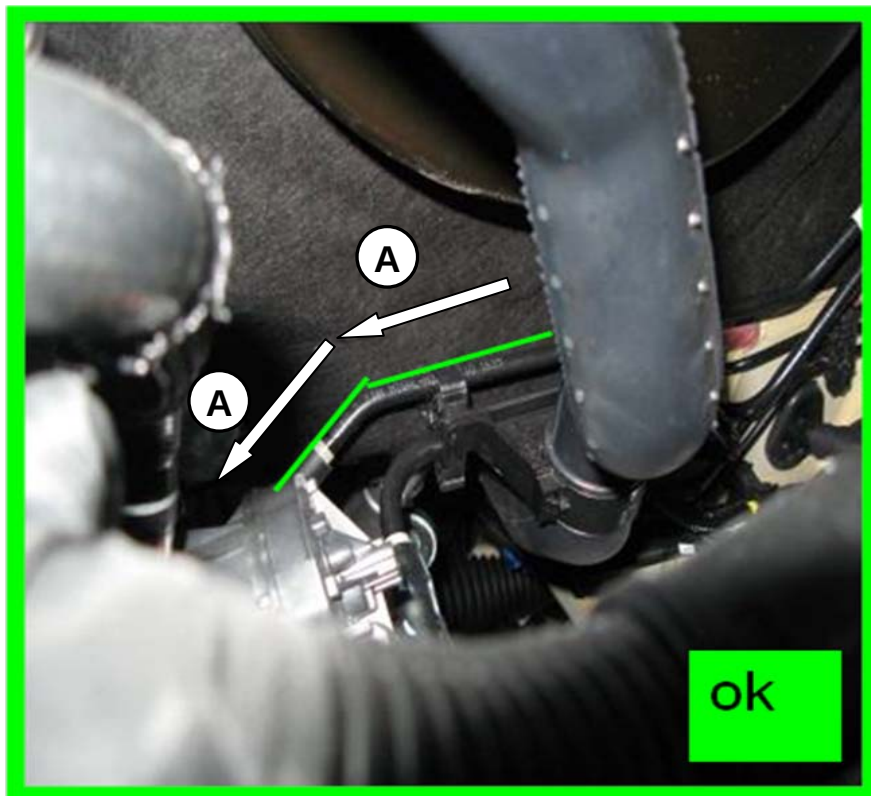
Fig. 1

- Identify the supply pipe from fuel filter to duplex pipe.
- Check the path of the pipe.
- If the path of the pipe is as shown (A) following the direction of the arrows (Fig.1) with the bend of the pipe downwards, the vehicle is compliant.

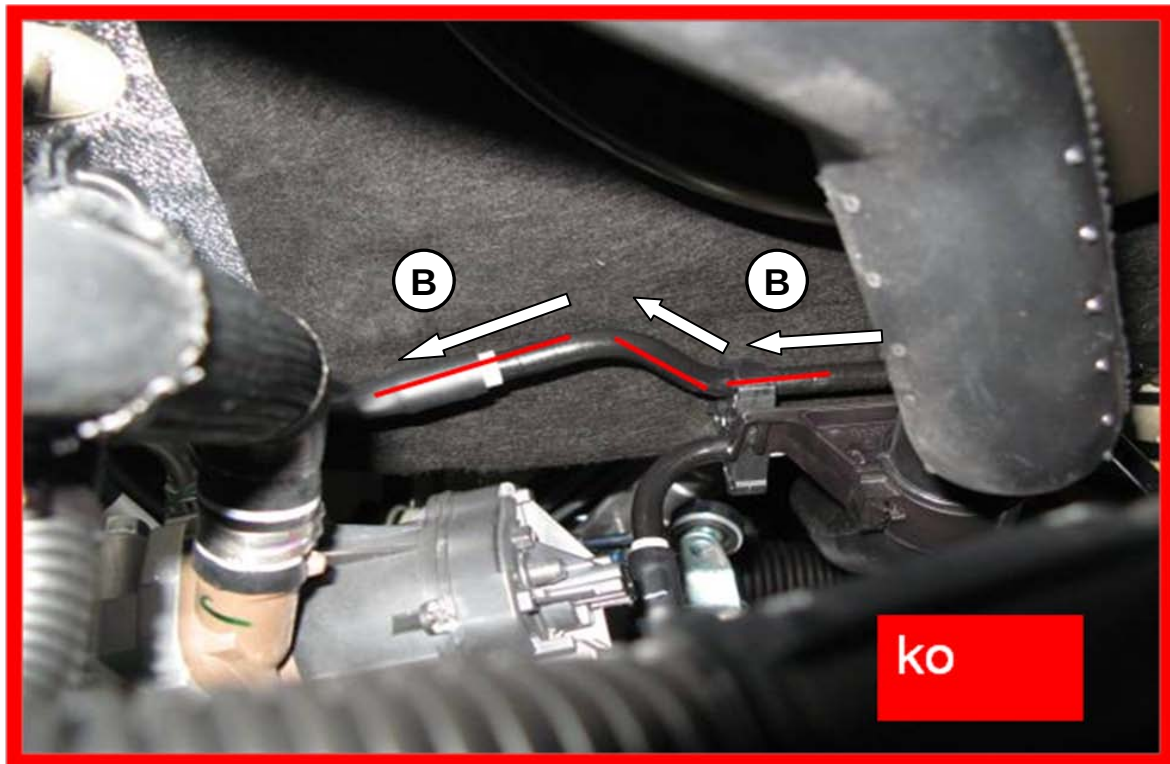
**Fig. 2**

- If the path of the pipe is as shown (B) following the direction of the arrows (Fig. 2), with the bend of the pipe upwards, or in any case other than shown in Fig. 1, the vehicle is not compliant and the pipe must be replaced proceeding as follows:
- Replace the pipe (see Part&Service availability), as described in operation 1040B40 of the Service Manual.

- Refit the complete under-engine guard on the vehicle if previously removed.
- Remove the vehicle from the lift
