Turin, 5<sup>th</sup> March 2013

**CAMPAIGN 5707 - Service Campaign**  
**Model: Fiat Ducato "recreational" version**  
**- rear fog light wiring**

### 5707

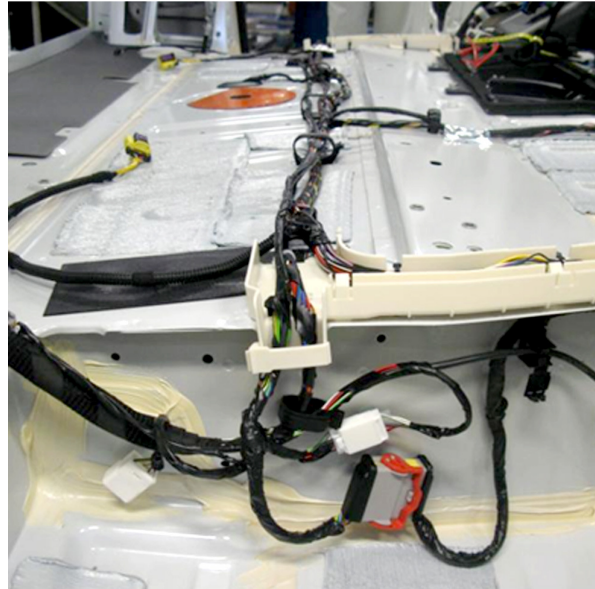
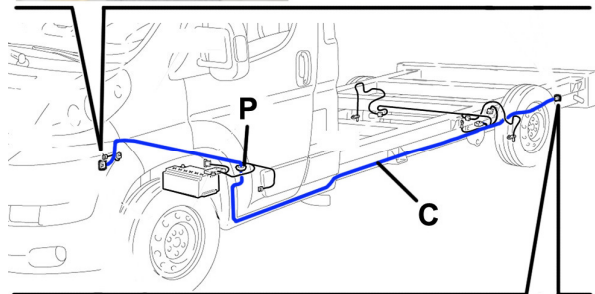
- Make the harness (C) (marked in blue in the picture) pass following the path of the longitudinal left wiring, until reaching connection D224.

- Take out the protection plug from the pin 10 cavity of the connector block, then fit the terminal of the new harness.
- Suitably protect the connection with insulating tape.
