**CAMPAIGN 5656 - Service Campaign**

**Model: Fiat Ducato with 2.3 JTD 130 HP and 150 HP Euro 5 engine  
- blow-by pipe**

| COMPONENT: | BLOW-BY PIPE | | | |
| TECHNICAL CAUSE: | Lack of heating device | | | |

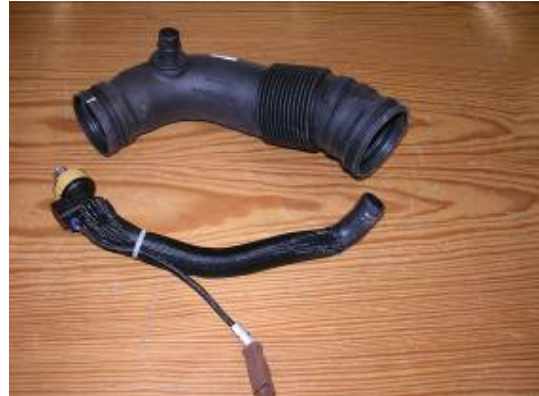
Take the new heated blow-by pipe and the air pipe to the turbocharger (see Part&Service availability)
