**CAMPAIGN 5832- Service Campaign**  
**Fiat Bravo Van, Doblò Cargo, Ducato 1.6 and 2.0 MultiJet models.**  
**- brake servo vacuum unit**

**Fiat Bravo Van / Fiat Doblò Cargo / Fiat Ducato models, with 1.6 / 2.0 MultiJet engines.  
- brake servo vacuum unit**

# CAMPAIGN

### 5832

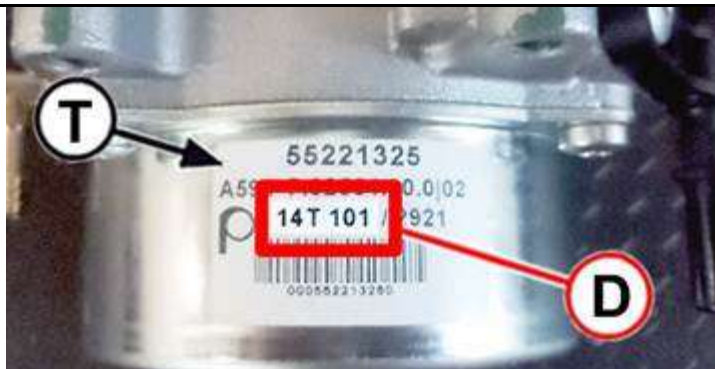
### Cycle V - Conformity check valid for: Bravo Van 1.6 and 2.0 MJet models Doblò Cargo 1.6 and 2.0 MJet models

- Remove the sound-proof cover, with reference to Op. 1016A10.
- Check conformity of the vacuum unit: the acronym (D), on the plate (T), is structured as follows: **14T** = year 2014 and the day of manufacturing, number 101 (as in the example in the figure) corresponds to the 101st day of the year, that is 11 April.

If the number related to the day of manufacturing is:

- lower or equal to **99**;
- equal or higher than **137**;

the vacuum unit is compliant = **OK**,  
no intervention is required.

- comprised between: **100** and **136**  
the vacuum unit is NOT compliant = **KO**, replace it as described below.

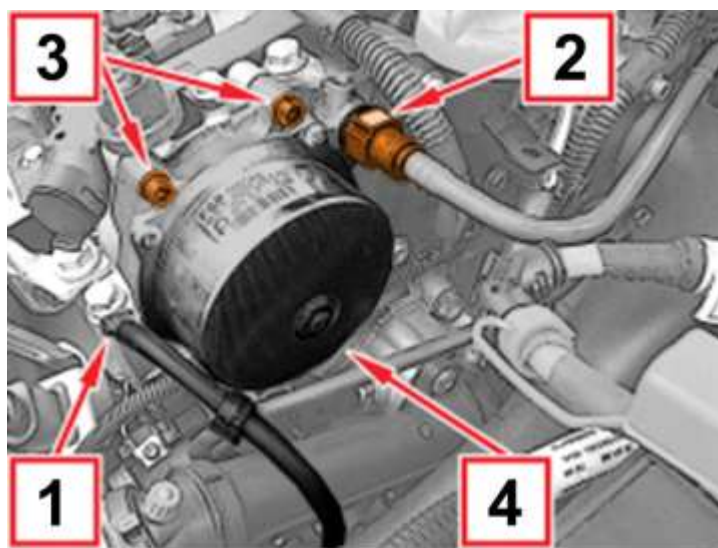
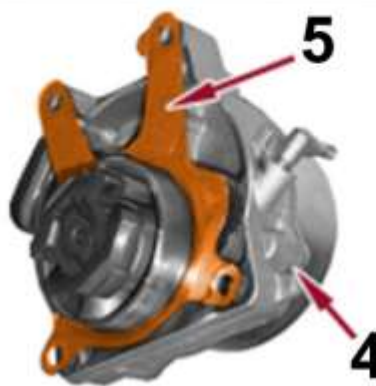
### Cycle A - Applies to models: Bravo Van 1.6 and 2.0 MJet models;

- Release the reservoir vacuum pipe (1) from the mounting clip and disconnect it from the vacuum unit.
- Disconnect the quick coupling (2) for the brake servo vacuum pipe from the vacuum unit.
- Loosen the screws (3) and remove the vacuum unit (4).

- a new vacuum unit;
- a new seal;
- four new fastening screws.
- Fit the new vacuum unit (4) complete with the new seal (5) in its housing.
- Tighten the new fastening screws at a torque of  $0.4 \div 0.6 \text{ daNm} + 50^\circ \pm 2^\circ$ .
- Connect the quick coupling (2) for the brake servo vacuum pipe to the vacuum unit.
- Connect the reservoir vacuum pipe (1) to the vacuum unit.

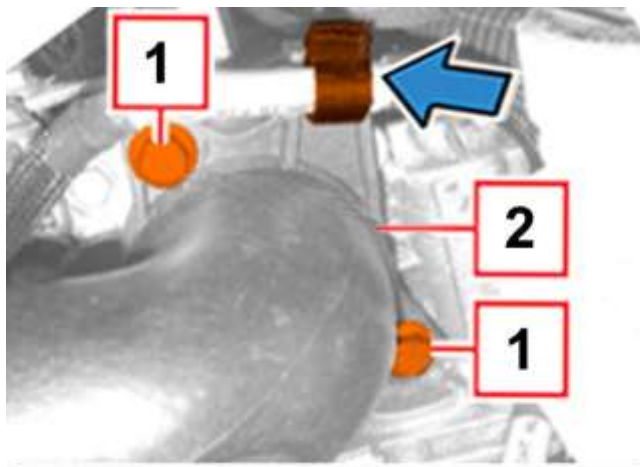
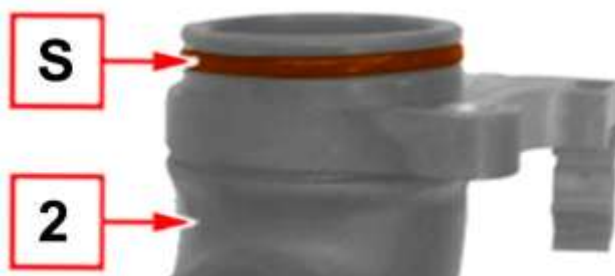
## Cycle B - Applies to Doblò Cargo 1.6 and 2.0 MJet models

- Open the indicated retaining clip and loosen the screws (1) fixing the air inlet pipe (2) to the throttle body.
- Loosen the screw fastening the pipe to the gearbox and release the mounting clips.
- Disconnect and move the pipe (2) aside to clear the working area, and remove the O-ring (S).

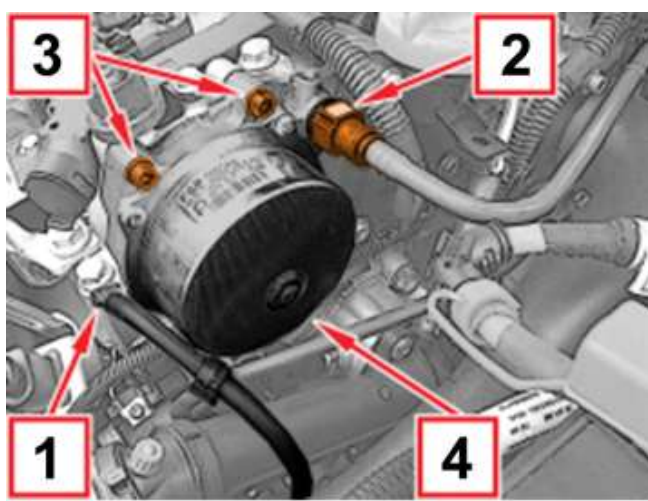
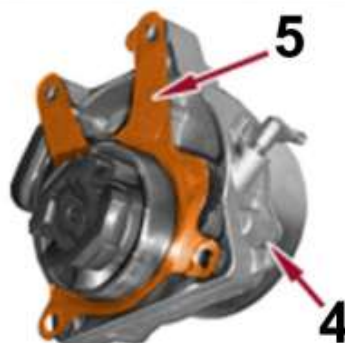
- Disconnect the reservoir vacuum pipe (1) from the vacuum unit.
- Disconnect the quick coupling (2) for the brake servo vacuum pipe from the vacuum unit.
- Loosen the screws (3) and remove the vacuum unit (4).

- a new vacuum unit;
- a new seal;
- four new screws;
- a seal for the air inlet pipe.
- Fit the new vacuum unit (4) complete with the new seal (5) in its housing.
- Tighten the new fastening screws at a torque of  $0.4 \div 0.6 \text{ daNm} + 50^\circ \pm 2^\circ$ .
- Connect the quick coupling (2) for the brake servo vacuum pipe to the vacuum unit.
- Connect the reservoir vacuum pipe (1) to the vacuum unit.

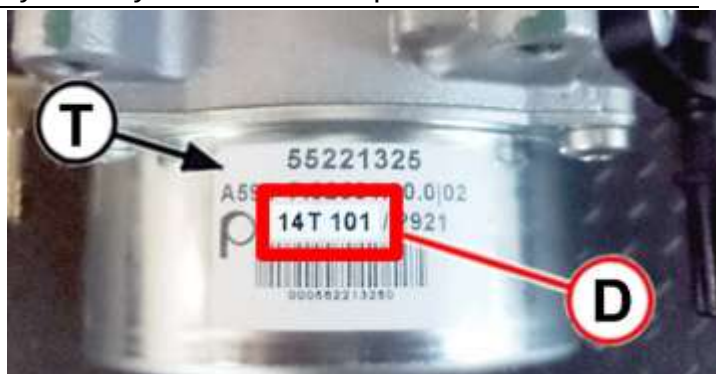
### Cycle V - Conformity check: applies to Ducato 250 2.0 MJet model

- Remove the battery cover, with reference to Op. 5530B54.
  - Disconnect the negative battery terminal.
  - Remove the sound-proof cover, with reference to Op. 1016A10.
- 
- Check conformity of the vacuum unit: the acronym (D), on the plate (T), is structured as follows: **14T** = year 2014 and the day of manufacturing, number 101 (as in the example in the figure) corresponds to the 101st day of the year, that is 11 April

If the number related to the day of manufacturing is:

- lower or equal to **99**;
- equal or higher than **137**;

the vacuum unit is compliant = **OK**, no intervention is required.

- comprised between: **100** and **136**;
- the vacuum unit **is NOT compliant** = **KO**, replace it as described below.
-

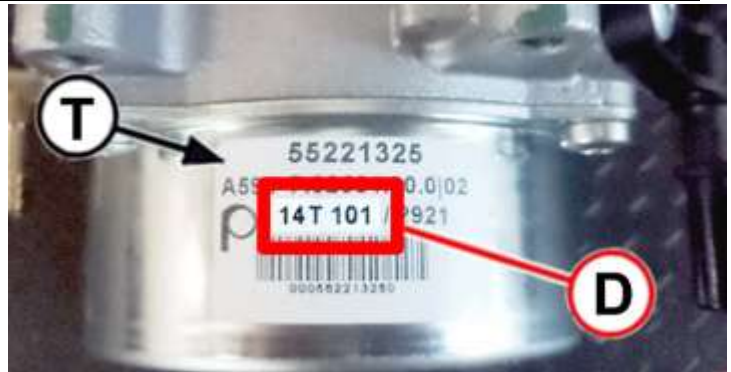
## Cycle V - Conformity check: applies to Ducato 290 2.0 MJet model.

- Check conformity of the vacuum unit: the acronym (D), on the plate (T), is structured as follows: **14T** = year 2014 and the day of manufacturing, number 101 (as in the example in the figure) corresponds to the 101st day of the year, that is 11 April.
-

If the number related to the day of manufacturing is:

- lower or equal to **99**;
- equal or higher than **137**;

the vacuum unit is compliant = **OK**, no intervention is required.

- comprised between: **100** and **136**;

the vacuum unit is **NOT compliant** = **KO**, replace it as described below.
